Plasma[®] High Performance Rope

Inspection Guidelines

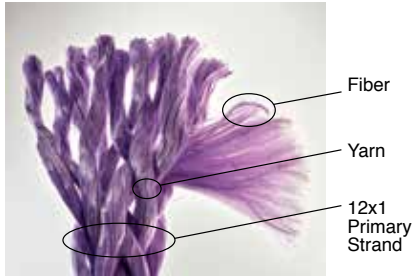
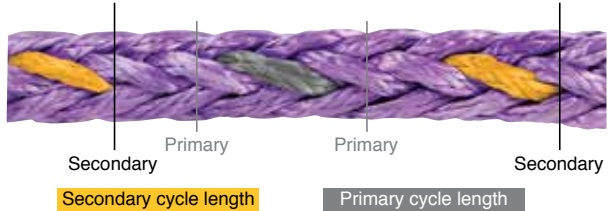
Inspecting Plasma® Rope

6 or more cut yarns within a **Secondary** cycle length—must repair or retire
3 or more cut yarns within a **Primary** cycle length—must repair or retire rope

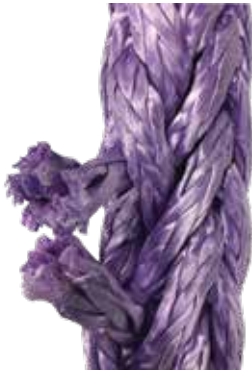
Distortion

Reference retirement
criteria #2

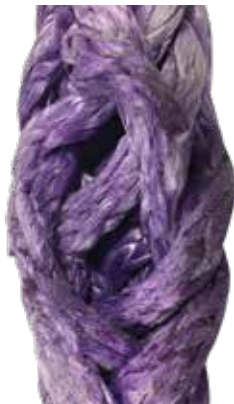
External

Abrasion level 1: normal wear—rope is showing normal wear, internal and external yarn shows light fuzziness and compression.

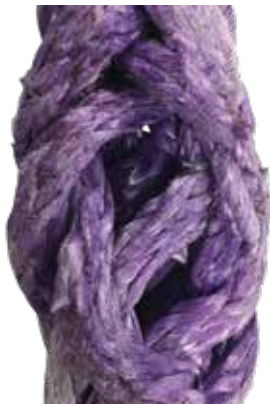
External

Abrasion level 2: normal wear—rope has more abrasion internally and externally, some slight total yarn volume loss, but rope is still good for use.

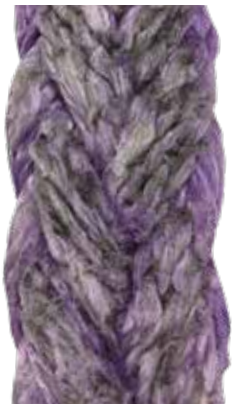
External

Abrasion level 3: normal wear—heavy internal abrasion, compression and diameter change. Carefully inspect for multiple cut yarns and full strands.

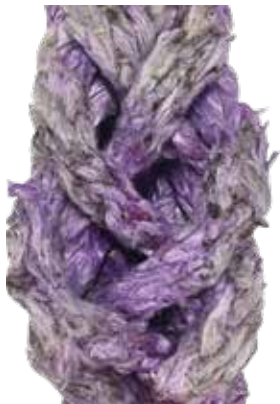
External

Abrasion level 4: caution—heavy internal abrasion and heat compression fusion of yarns. Also loss of fibers due to abrasion and cutting. Rope has probably lost a percentage of full new-rope strength. Carefully inspect for cut strands.

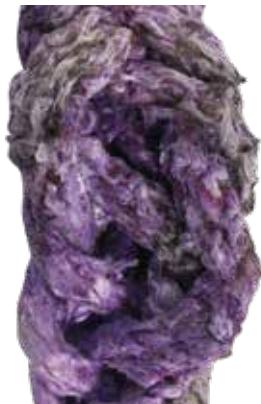
External

Abrasion level 5: remove rope from service—heavy external and internal heat compression, yarn volume loss and overall diameter size loss. Rope has lost a major percentage of its full new-rope strength.
