Plasma[®] High Performance Rope

Inspection Guidelines

2 step inspection and safe use guidelines for Cortland Plasma® 12-Strand and 12x12

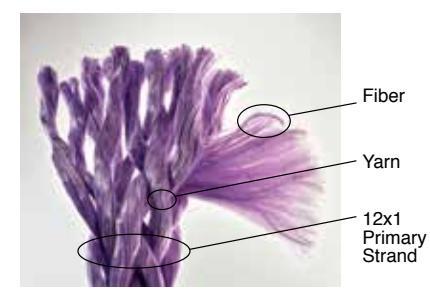
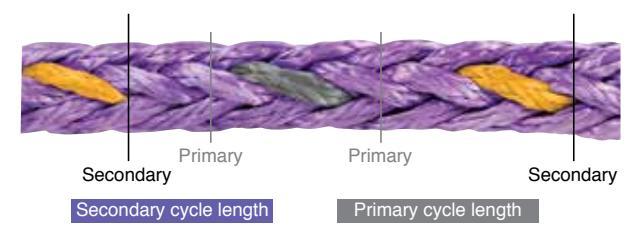
Inspecting Plasma[®] Rope

6 or more cut yarns within a **Secondary** cycle length—must repair or retire 3 or more cut yarns within a **Primary** cycle length—must repair or retire rope

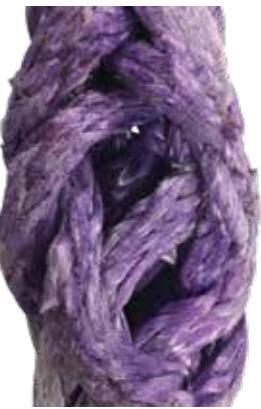
Abrasion level 2: normal wear—rope has more abrasion internally and externally, some slight total yarn volume loss, but rope is still good for use.

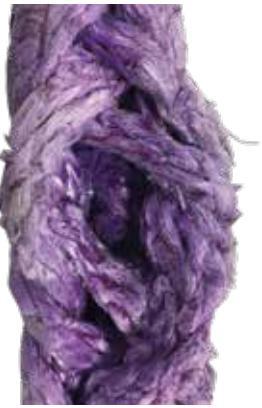
Abrasion level 3: normal wear—heavy internal abrasion, compression and diameter change. Carefully inspect for multiple cut yarns and full strands.

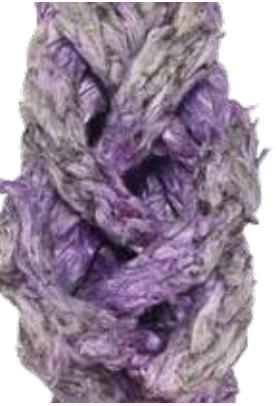
Abrasion level 4: caution—heavy internal abrasion and heat compression fusion of yarns. Also loss of fibers due to abrasion and cutting. Rope has probably lost a percentage of full new-rope strength. Carefully inspect for cut strands.

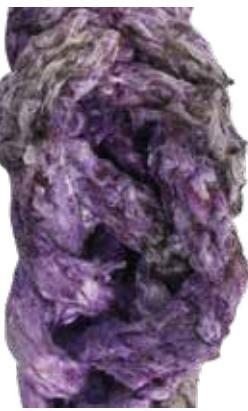
Abrasion level 5: remove rope from service—heavy external and internal heat compression, yarn volume loss and overall diameter size loss. Rope has lost a major percentage of its full new-rope strength.
